UNITED STATES COAST GUARD

REPORT OF INVESTIGATION INTO THE CIRCUMSTANCES SURROUNDING THE GROUNDING OF THE M/V MONTROSE ON FEBRUARY 28, 2007

MISLE ACTIVITY NUMBER: 2879209
ORIGINATING UNIT: SECTOR BALTIMORE
MISLE CASE NUMBER: 339349

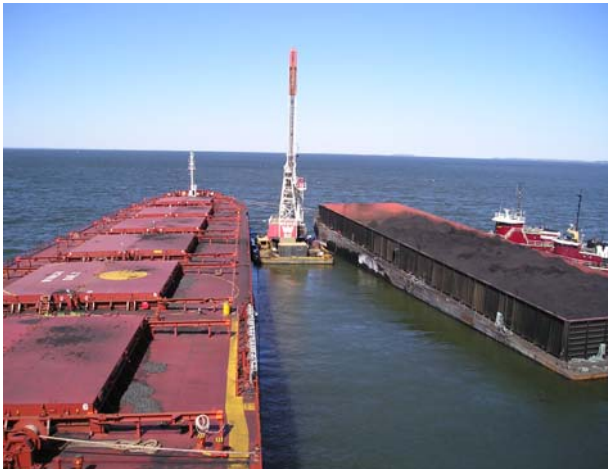
Figure 1: Coal Lightering Operations on the *Montrose*
